# **Post-disaster geotechnical response for hilly terrain: a case study from the Canterbury Earthquake Sequence**

Master of Science in Engineering Geology

University of Canterbury

**2014**

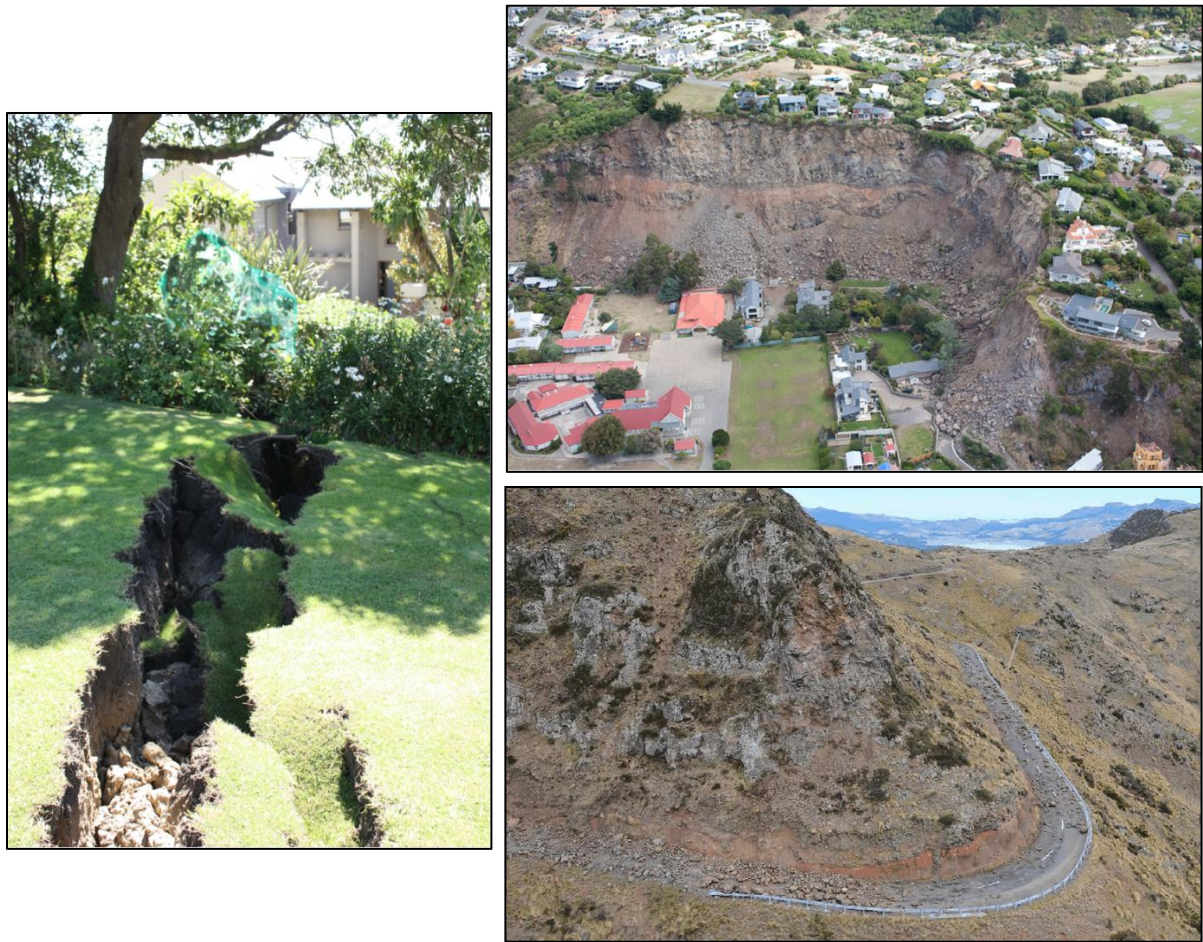
**Figure 1.6:** Illustration of the difference between Loess failure, Rockfall and Cliff Collapse. Photographs taken by M Villeneuve (left and top right); and GNS (bottom right).

Typically rockfall was released from joint controlled lava blocks from outcrops on valley walls (Figure 1.6). Sizes of the rocks which were released ranged from 0.1m<sup>3</sup> to 10m<sup>3</sup> depending on the spacing of jointing in the rock mass. Where joint spacing was greater than 1m rocks appeared to be more rounded (Dellow et al. 2011). Rockfall or boulder roll was one of the highest risk slope failure initiated by the earthquakes due to the velocity at which boulders and rocks generally progressed down slope, and in an unpredictable path. Further description of the classification and characteristics of rockfall is provided in Appendix A.

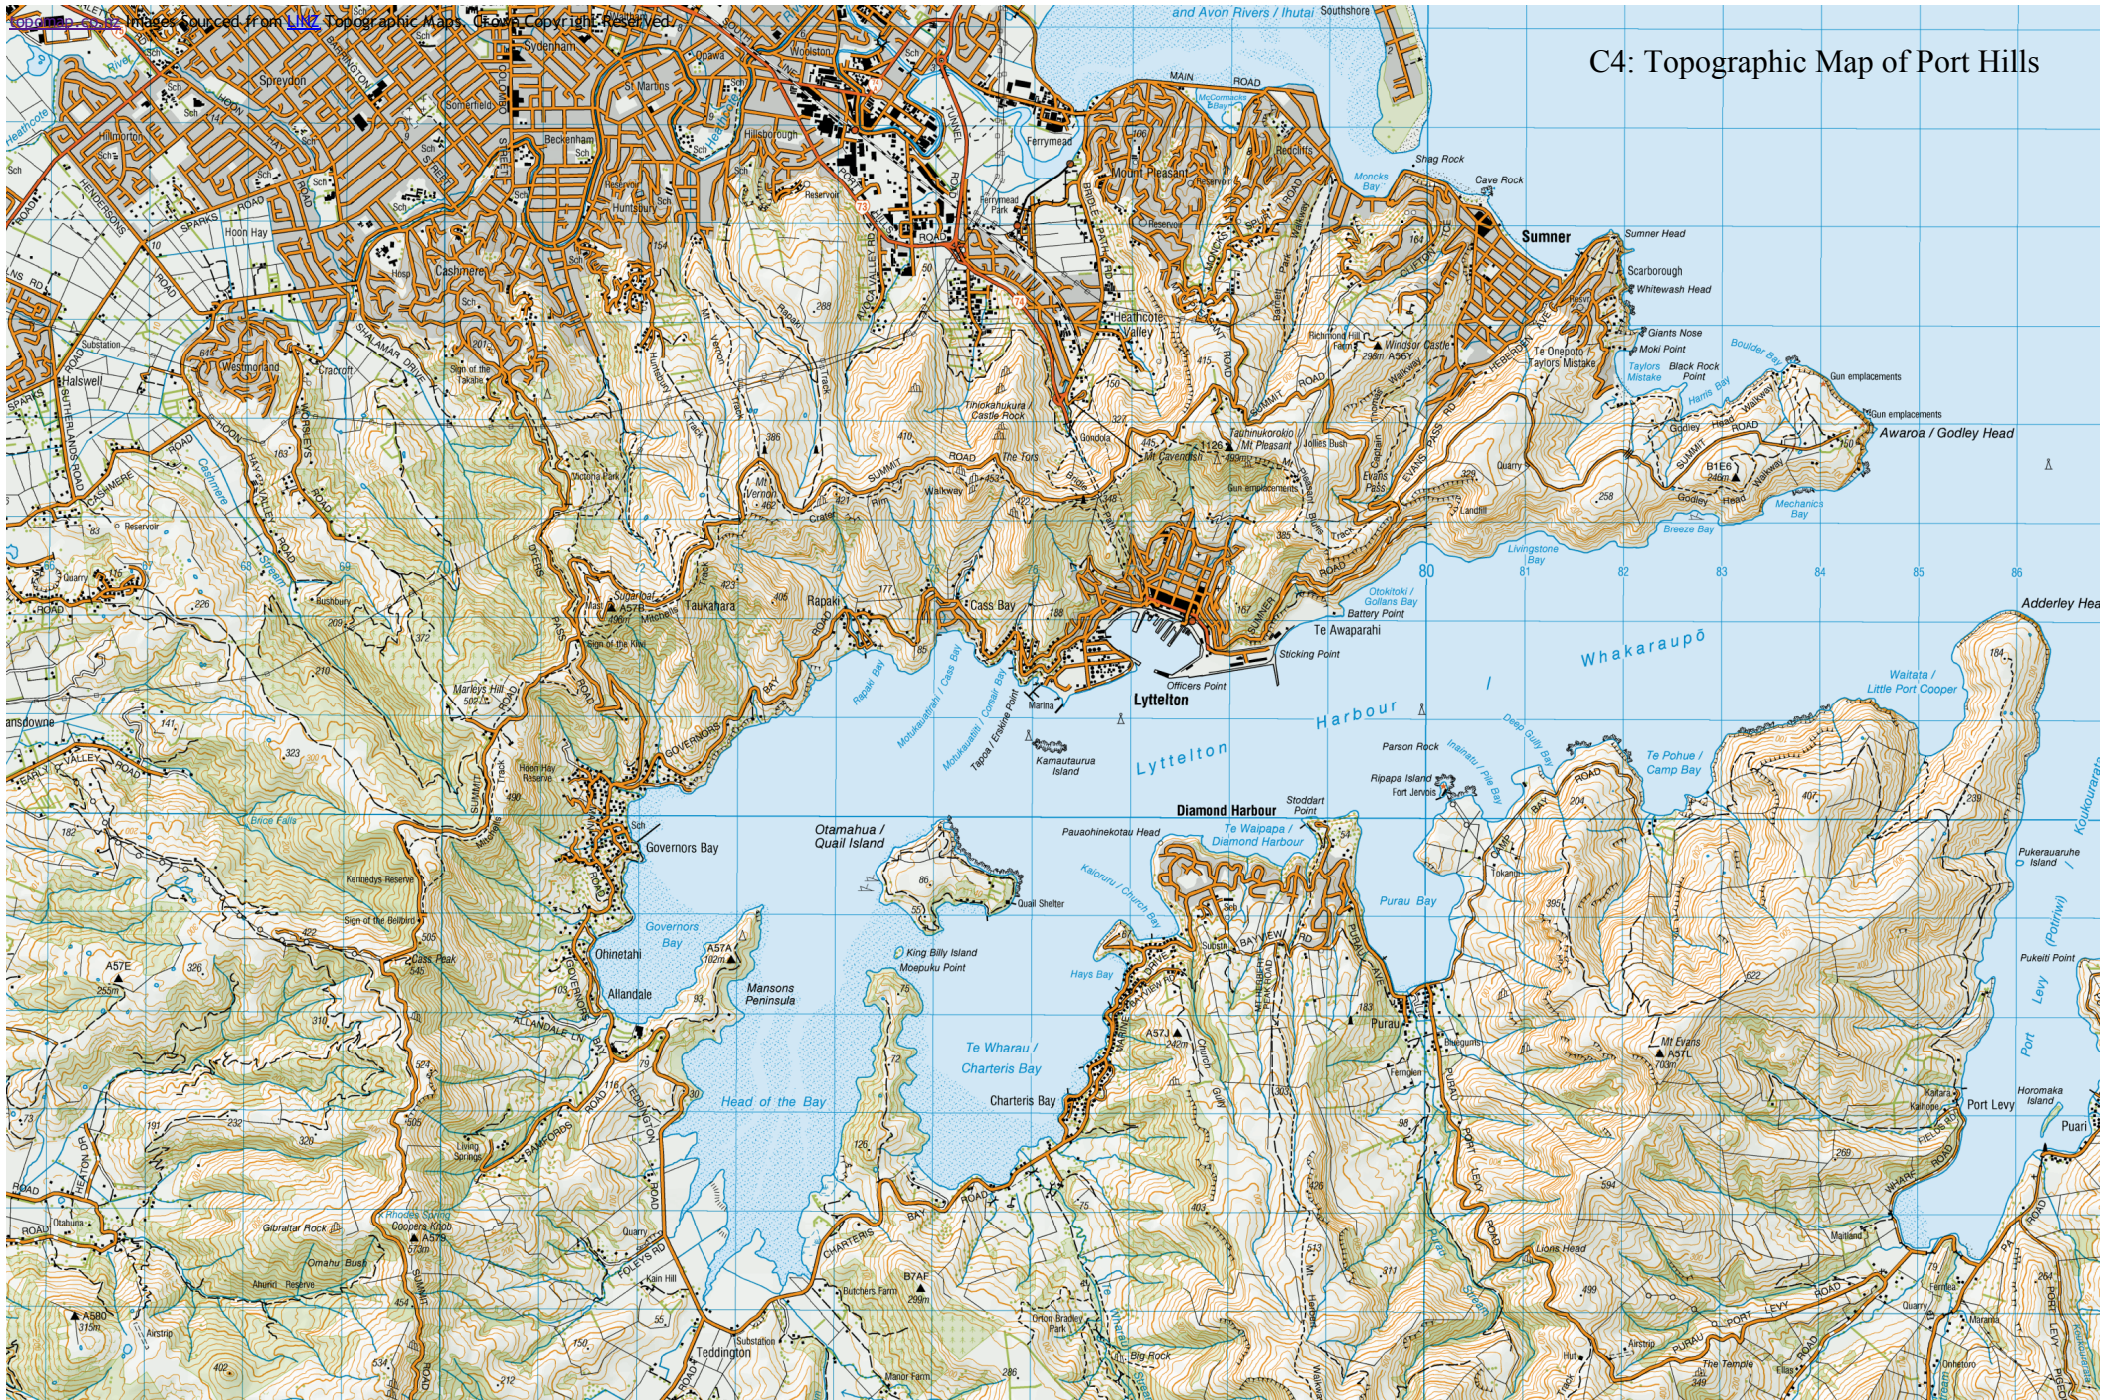
C3: 22<sup>nd</sup> Feb – 7<sup>th</sup> March 2011 Port Hills Geotechnical Response Timeline (2 week timeline)

PORT HILLS EVENTS								INVOLVEMENT							
Earthquake M <sub>w</sub> 6.2 – caused widespread rockfall, cliff collapse and landslides in Port Hills															
National State of Emergency declared Landslide response by USAR specialists, PHGG and GNS Science Landslide Recovery Team - Identify types of slope failure from aerial and ground reconnaissance

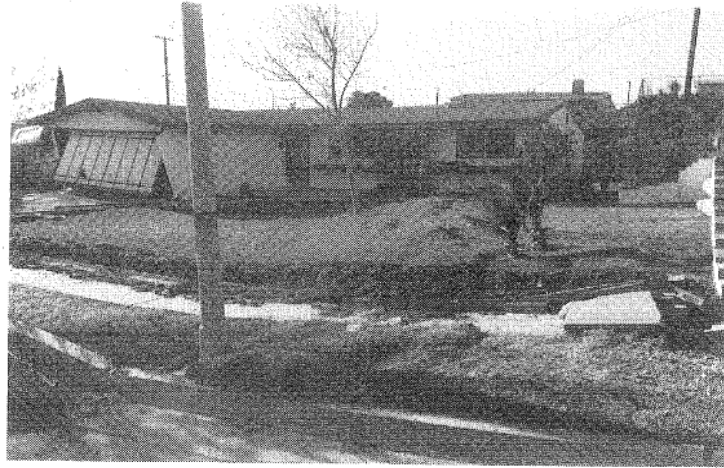
**Figure 11.2** *House damaged by ground displacements caused by surface faulting from the 1971 San Fernando, California, earthquake.*

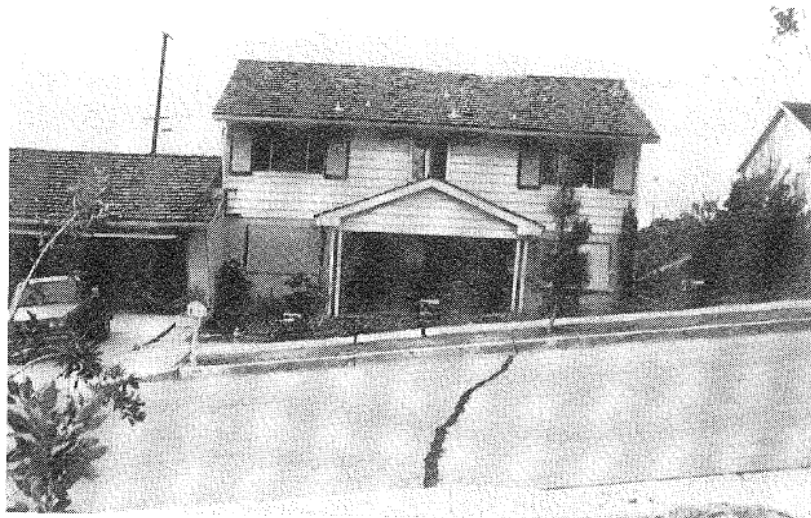
**Figure 11.3** *House and street damaged by several inches of landslide displacement caused by San Fernando earthquake.*

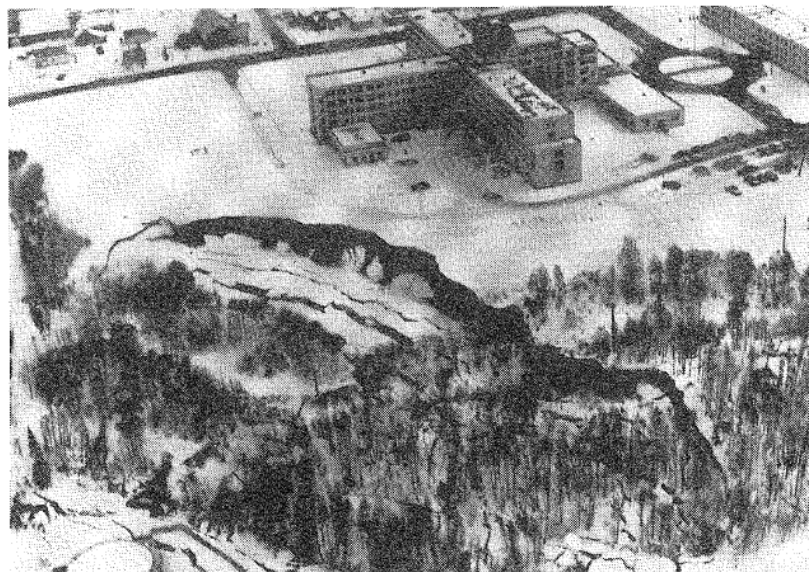
Figure 11.5 *Whenever large slides appear to threaten the safety of buildings, geotechnical specialists should assess the possibility of further movement.*

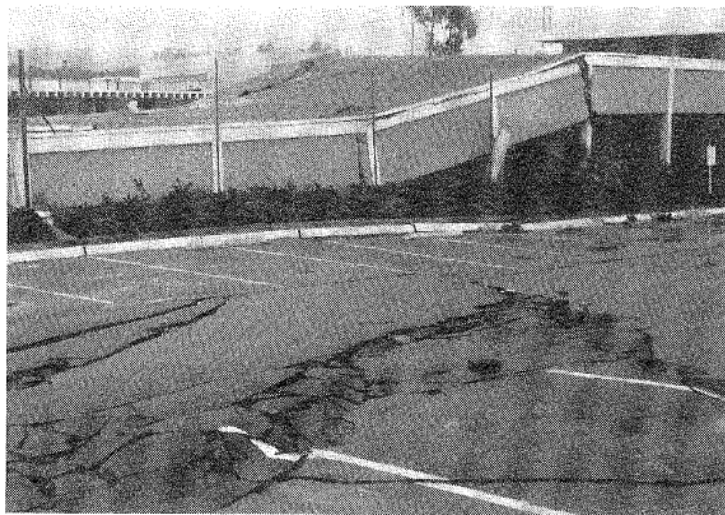
Figure 11.7 Damage to the San Fernando Valley Juvenile Hall caused by lateral spreading.
